LDEF and Other Lessons Learned

**Dr. Gary Pippin
Boeing ISDS**

**NASA SEE Workshop
Huntsville, Al
June 1998**

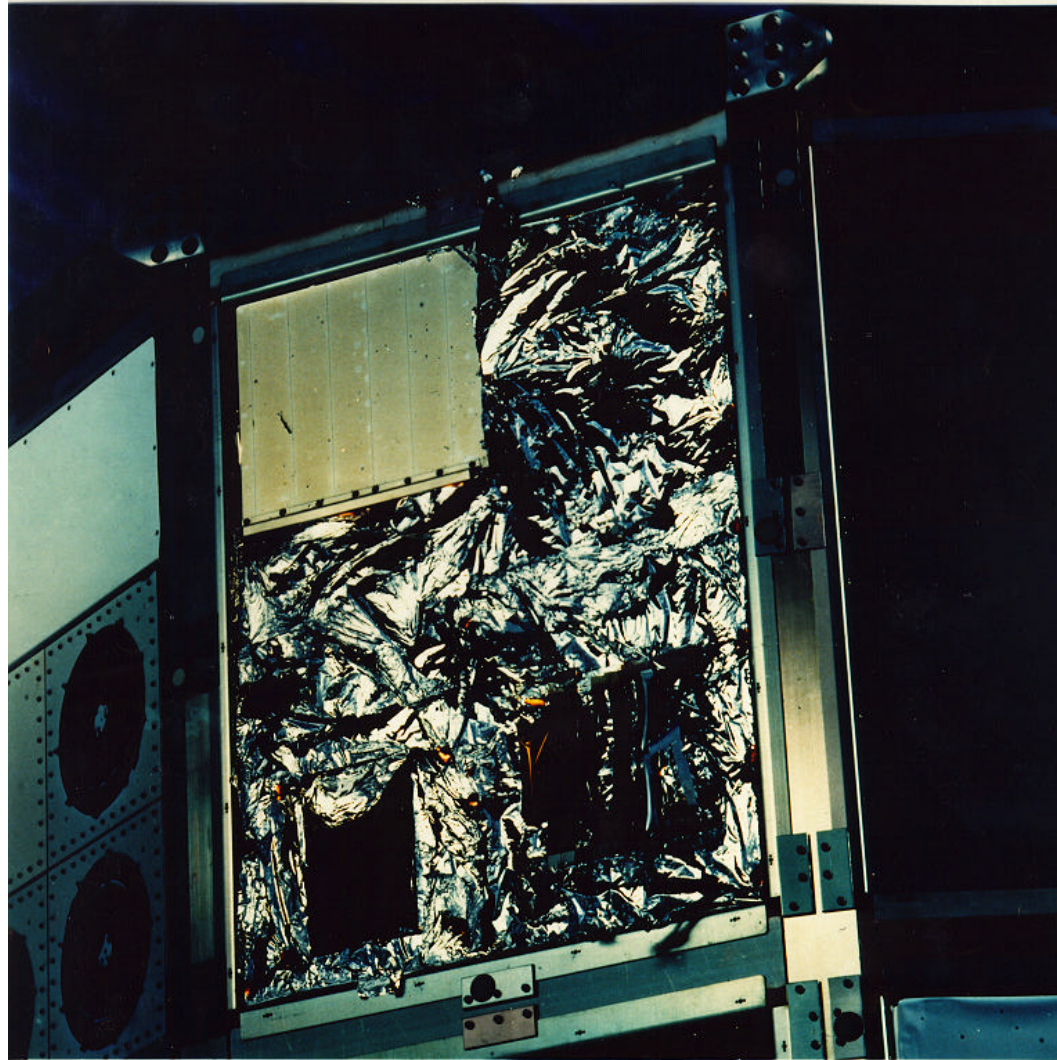
NASA On-orbit photo of tray F9 showing failed thermal control blanket

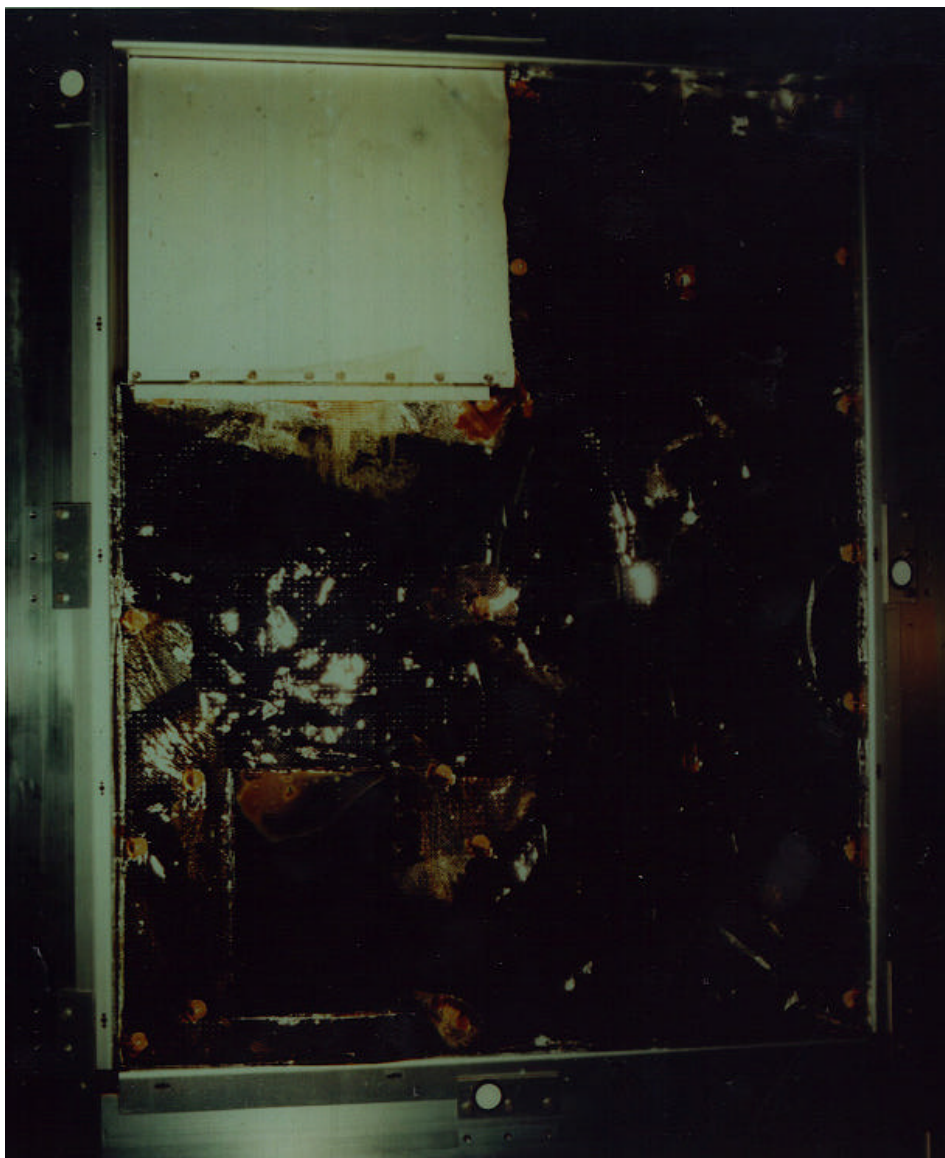
NASA Post-flight photo of tray F9

OBSERVED AND PREDICTED EROSION, FEP ANGLE BRACKET COVER, TRAY F9

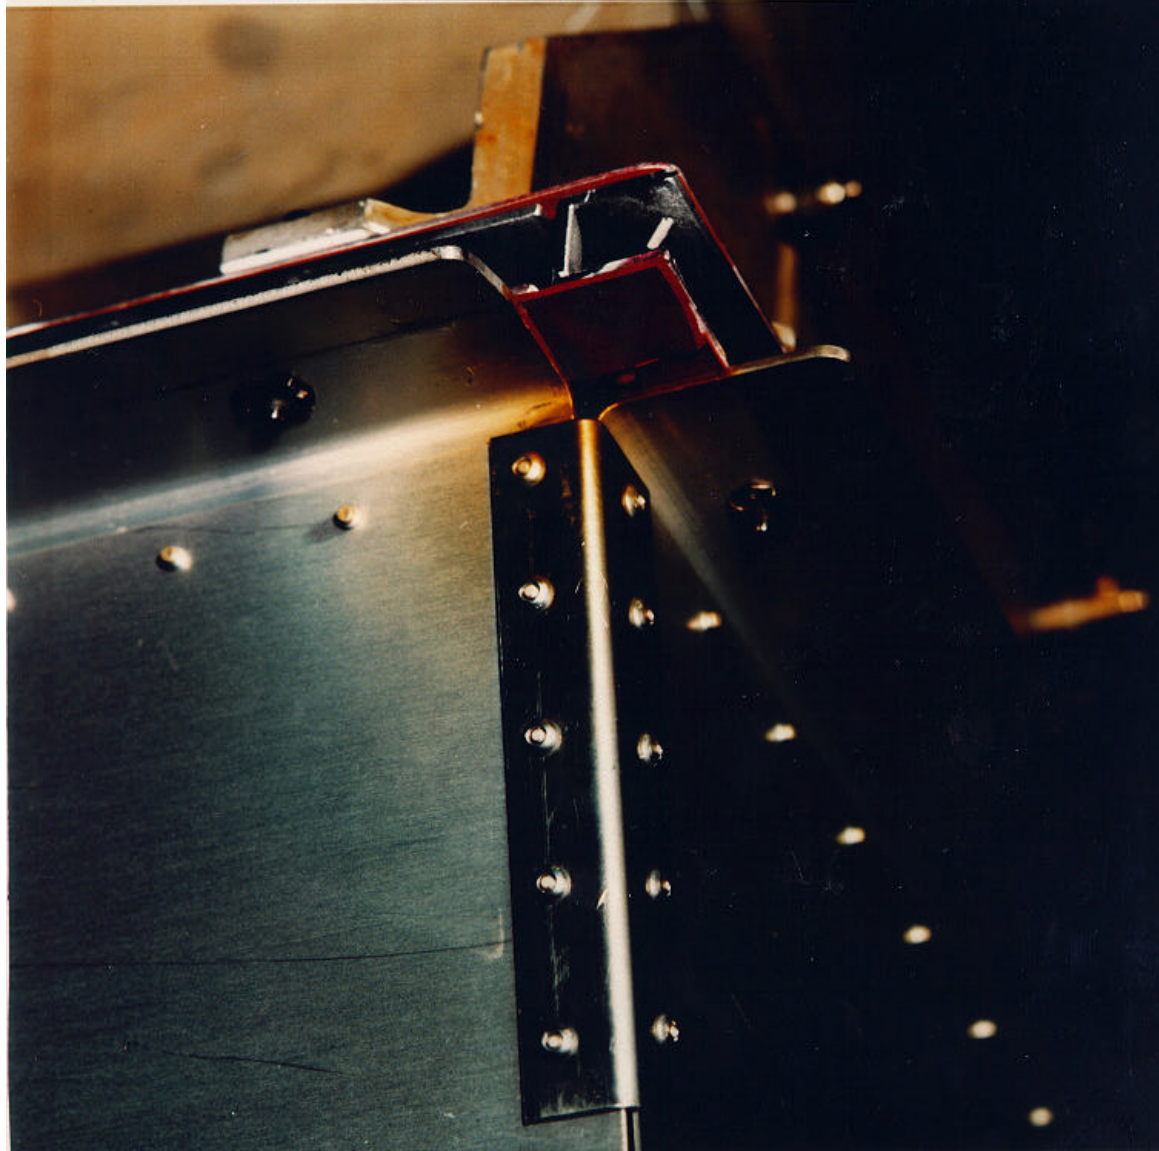
NASA Post-flight photo showing position of gasket relative to discoloration

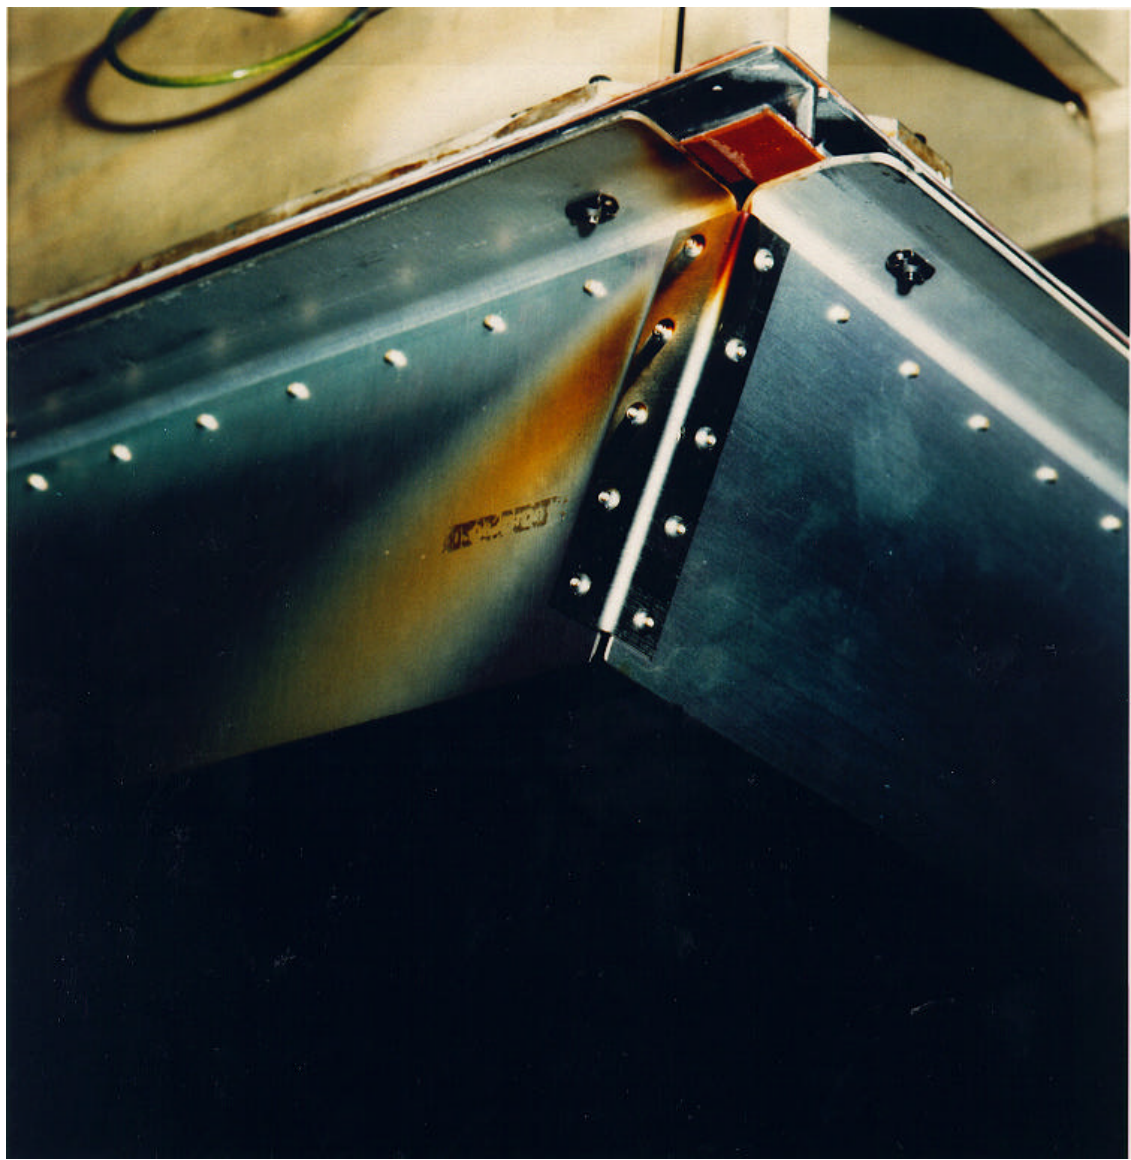
NASA Post-flight photo showing discoloration due to On-orbit exposure

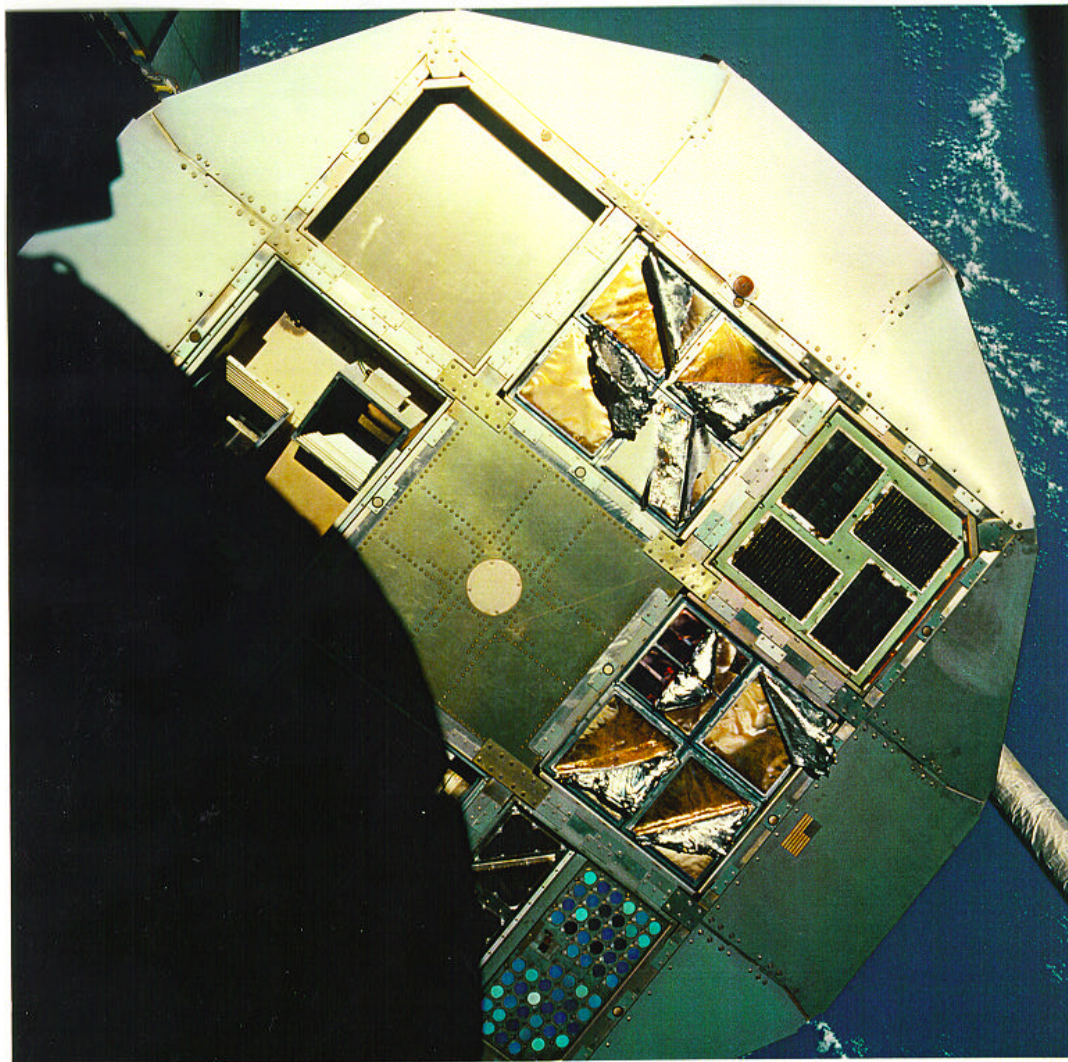
No stress relief of tape on NRL experiment

NASA On-orbit photo showing failure of tape holding thermal control blankets on space end of LDEF

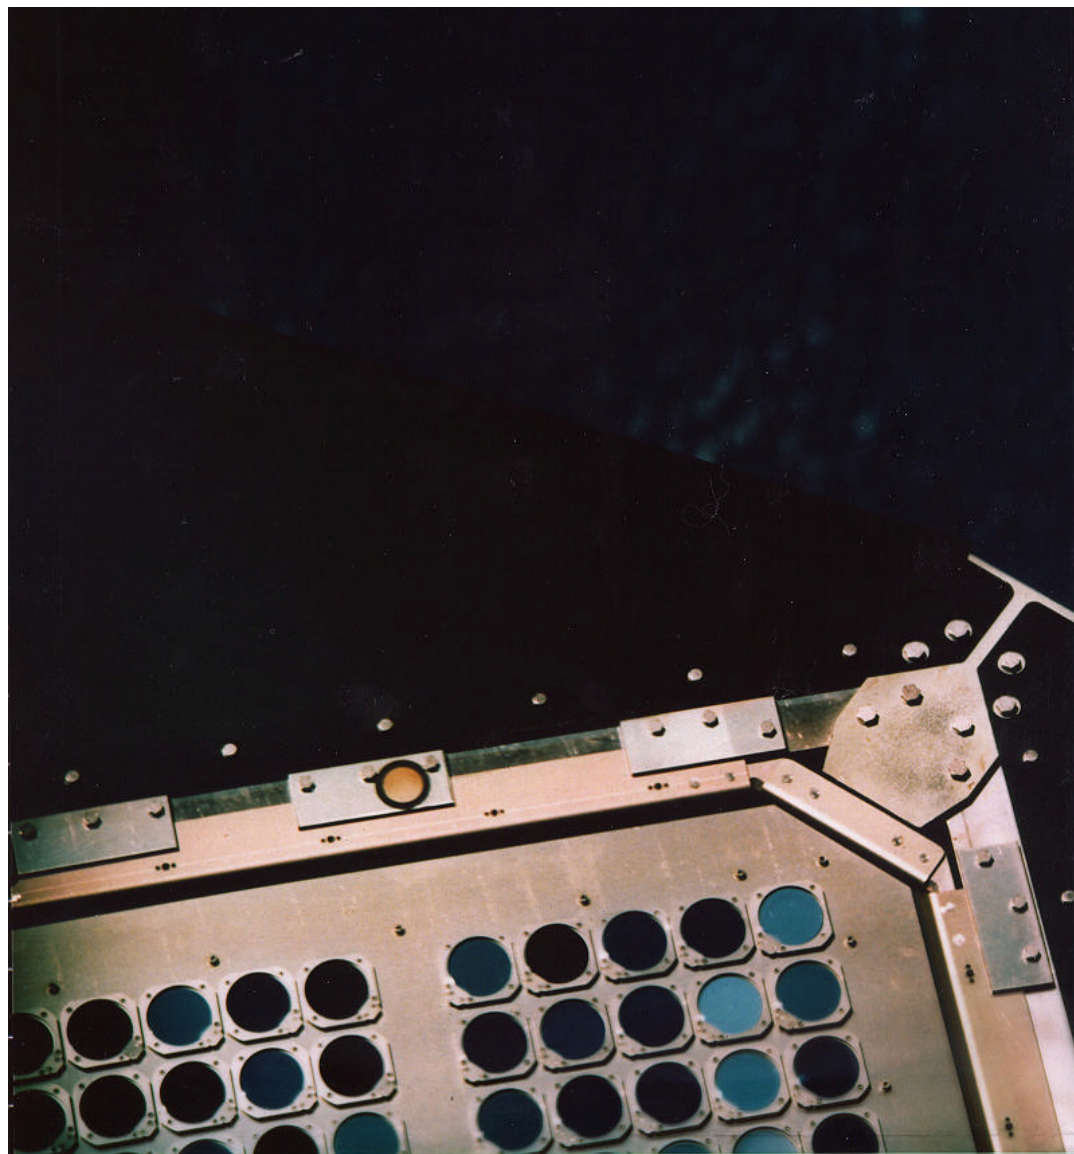
Handling of certain thermal control surfaces without gloves

NASA On-orbit photo showing fingerprints on Earth-end thermal panel

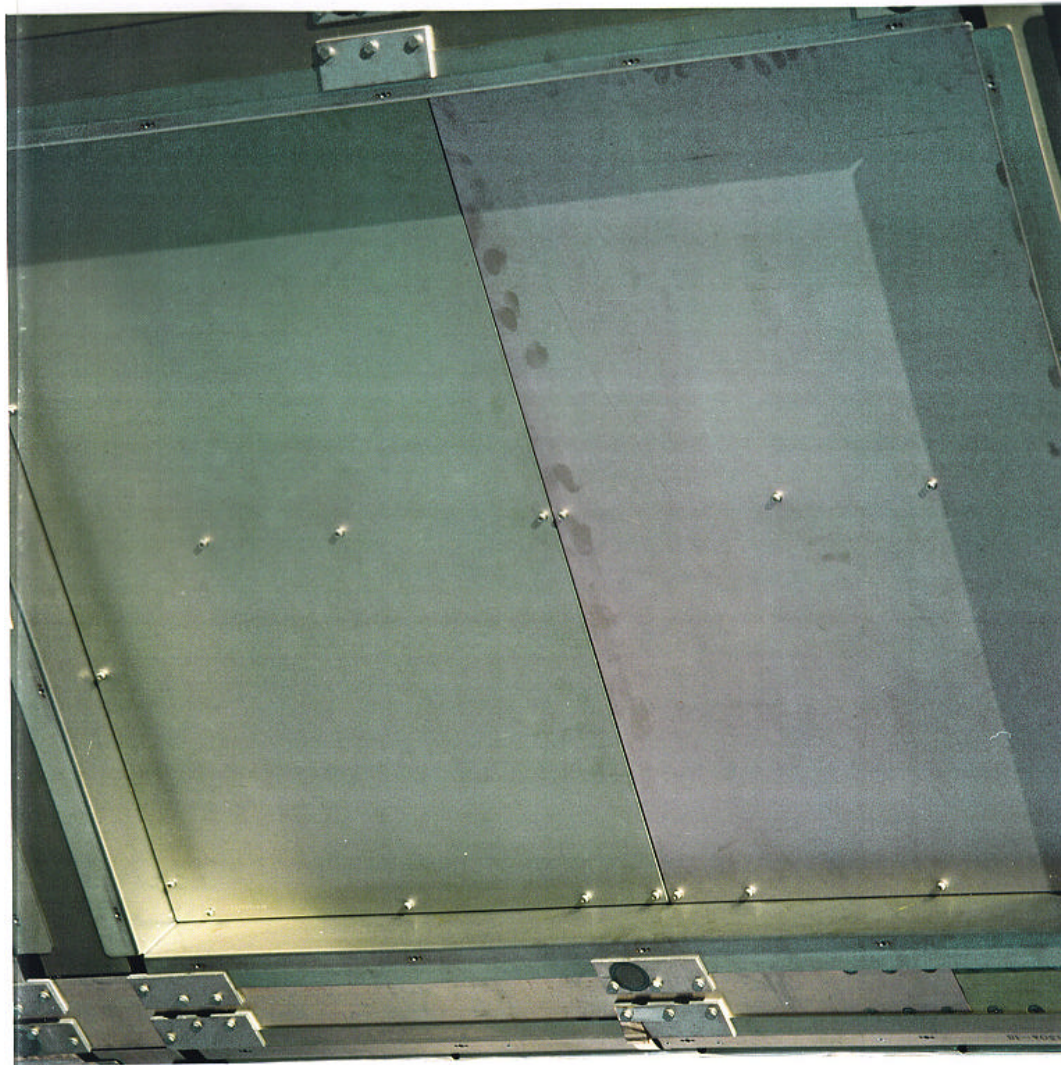
NASA On-orbit photo of thermal panels showing fingerprints from pre-flight handling

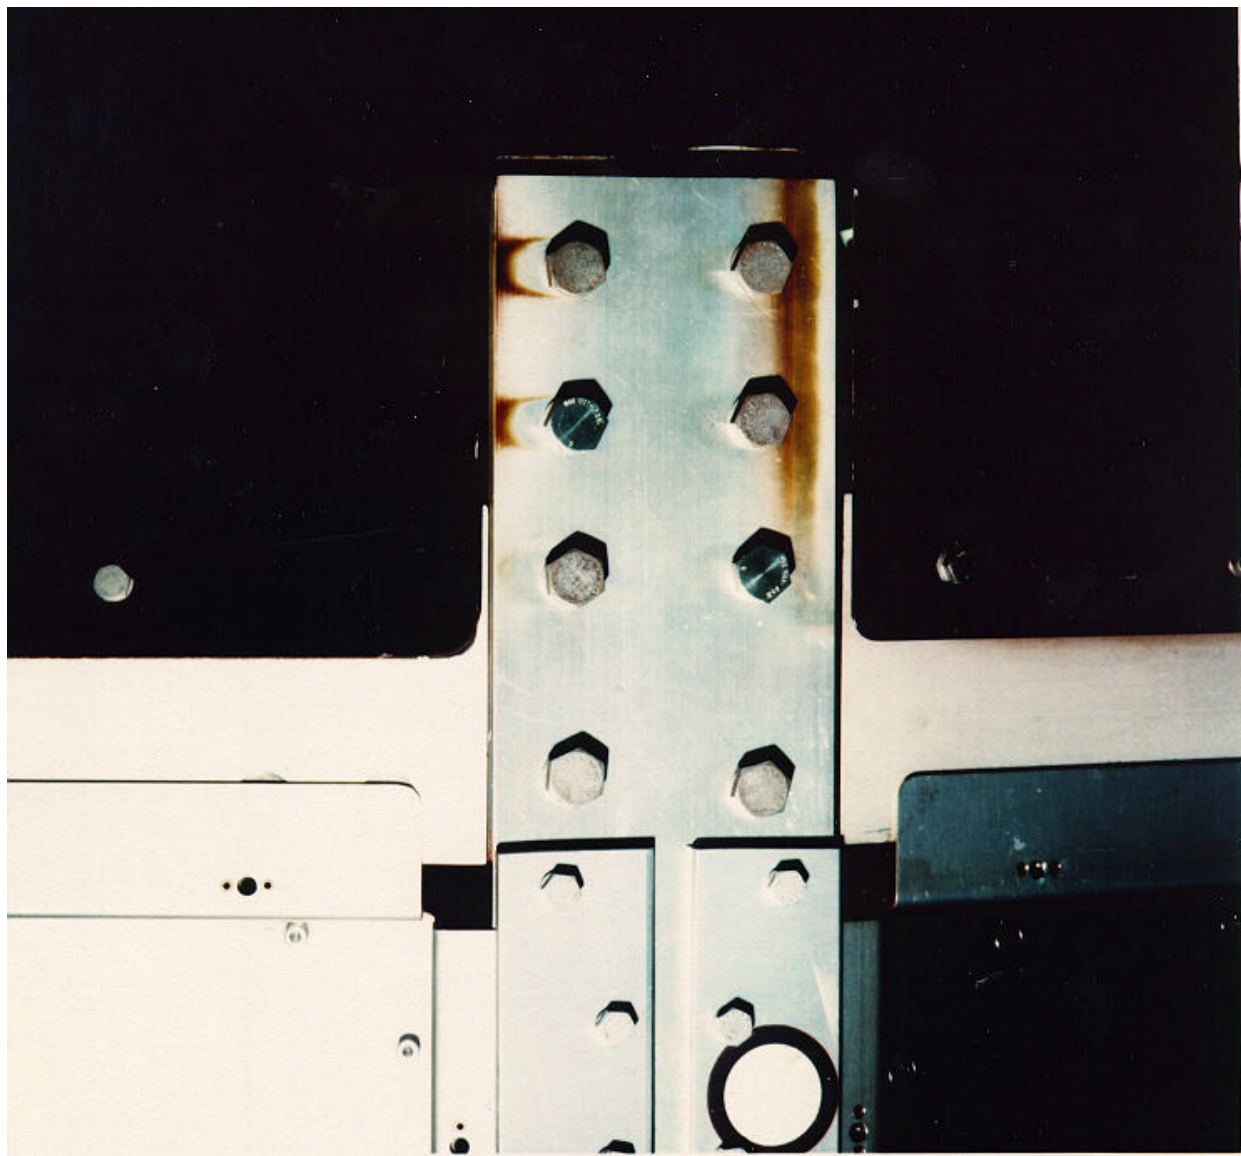
Thick Deposits close to Vents 2-3 cm

Line-of-sight Depositions

NASA photo showing Discoloration around vents from LDEF interior with pattern disrupted by presence of bolts

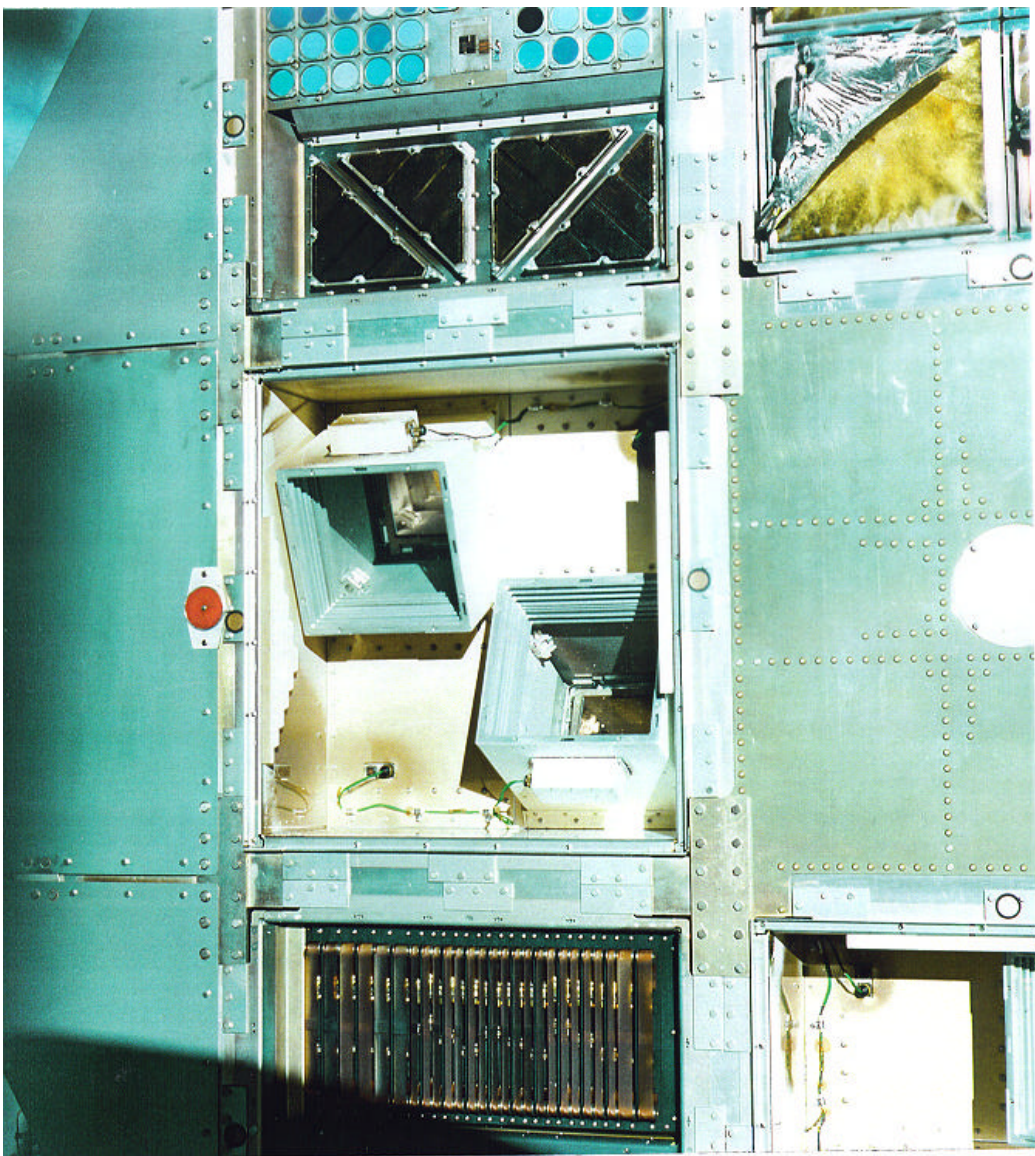
NASA On-orbit photo showing discoloration around vents on Interstellar Dust Experiment

**Severely darkened contaminant deposits around vents from interior
“Line-of-sight” molecular contaminant films observed**

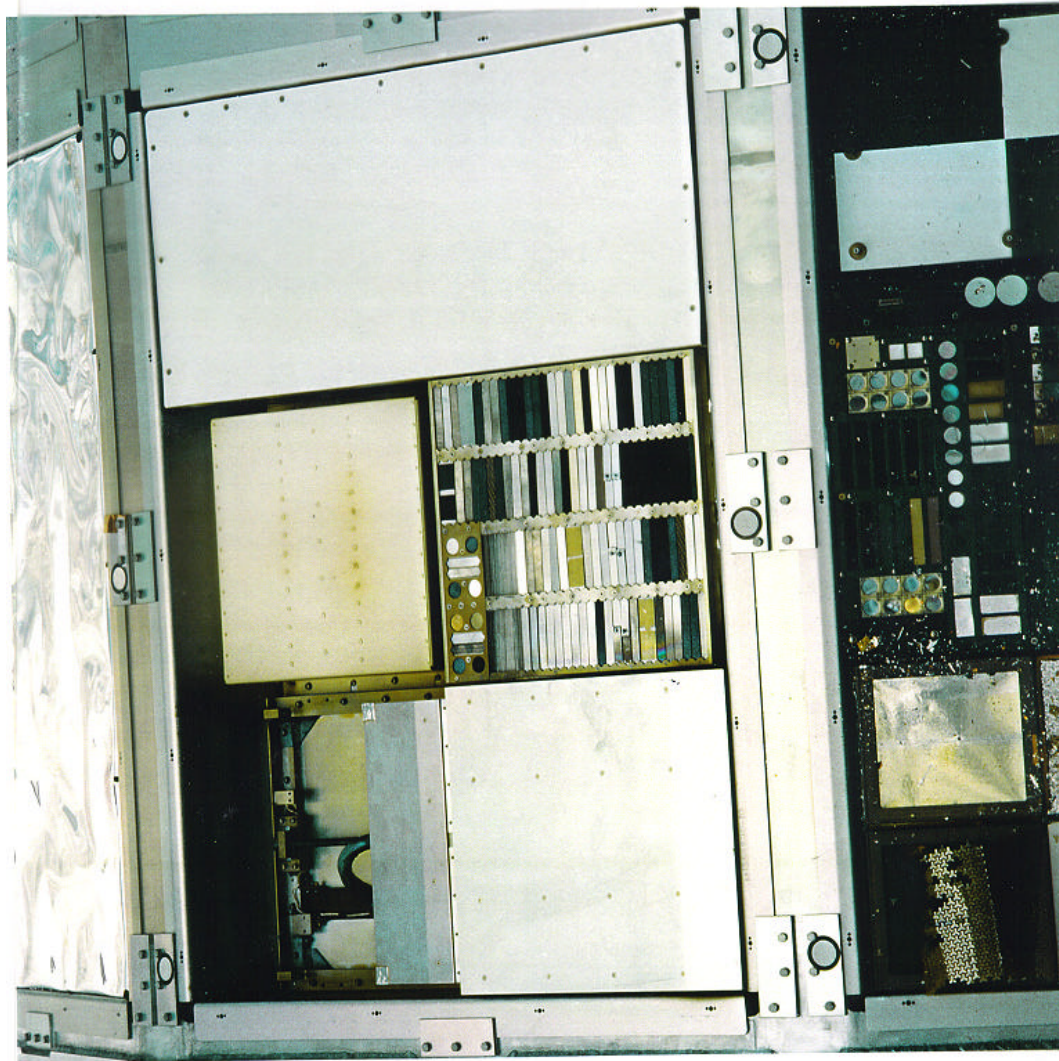
NASA On-orbit photo showing contamination around rivets and debris from mechanically failed hardware on right

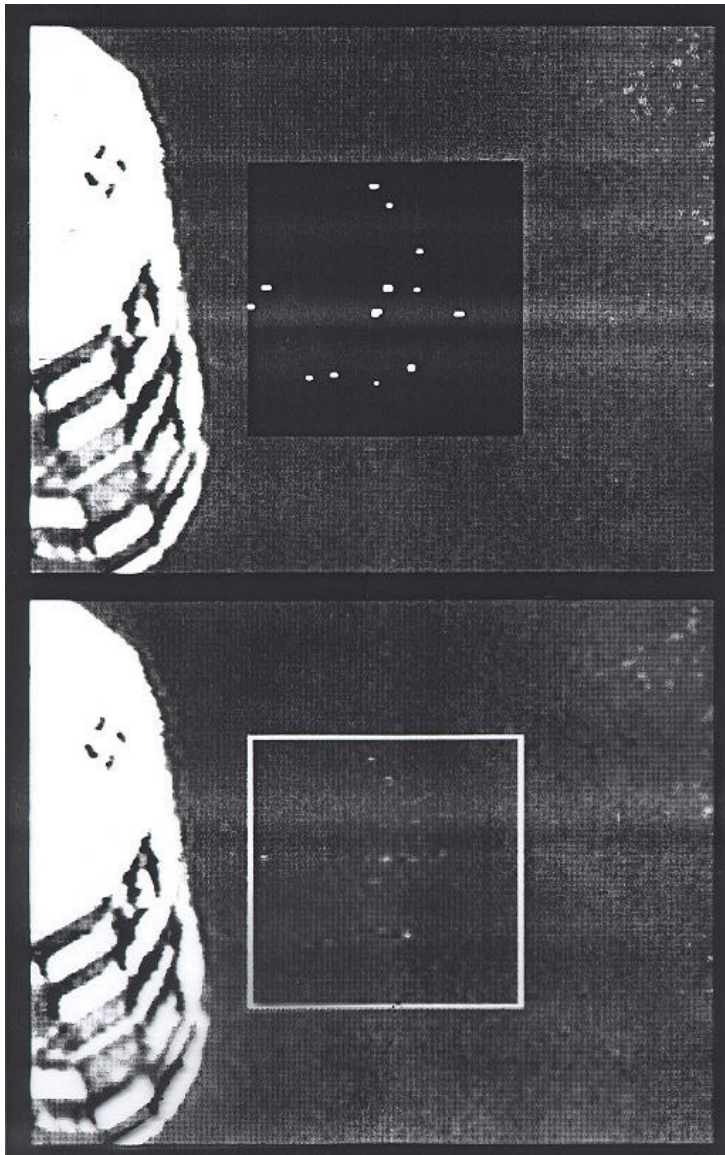
Computer enhanced image showing LDEF wake contamination particles

Mechanically failed films produced low-density debris cloud on LDEF wake side

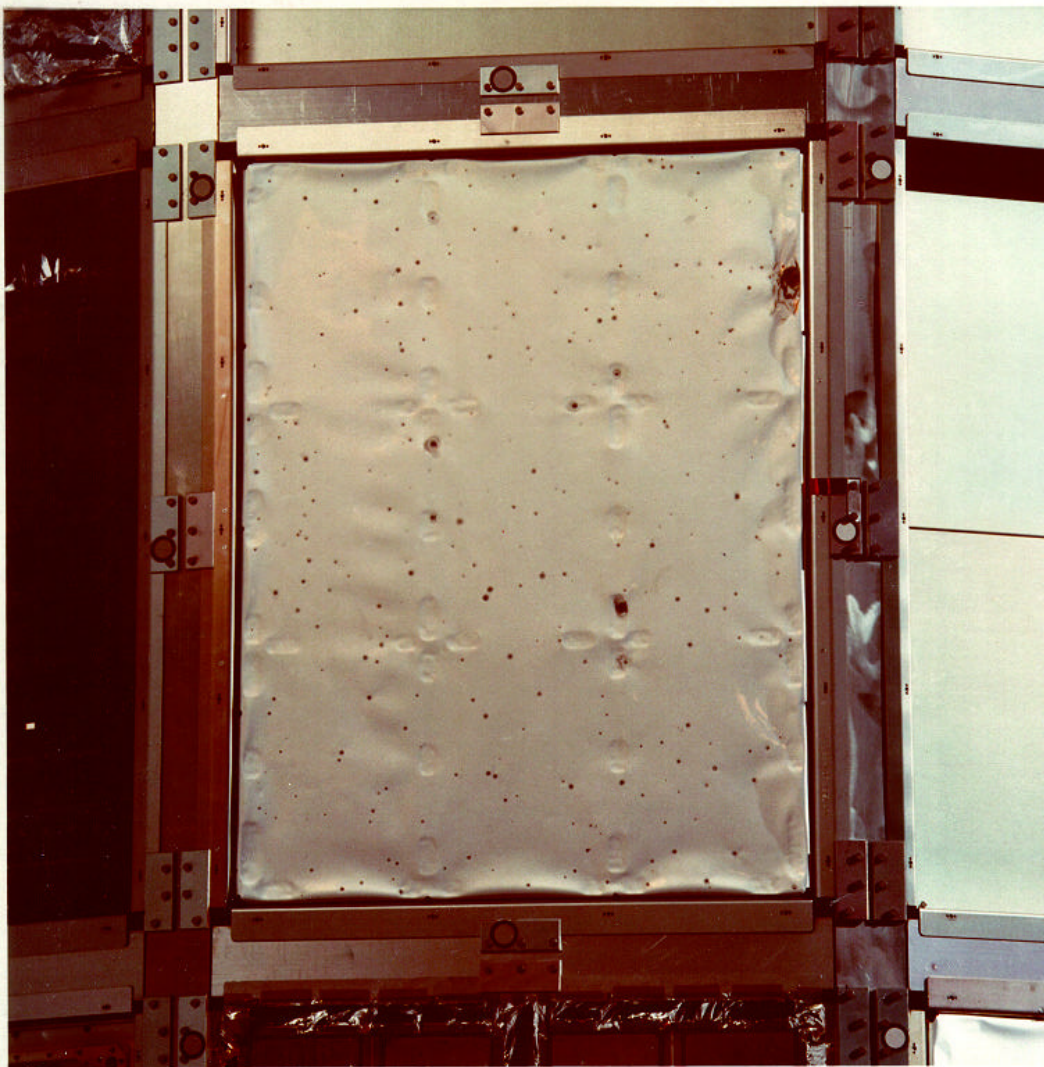
NASA On-orbit photo showing impact damage on thermal control blanket

**M&D impacts on Ag/FEP blankets
Worst case compromised ~2% of area, delaminated ~5% of blanket area**

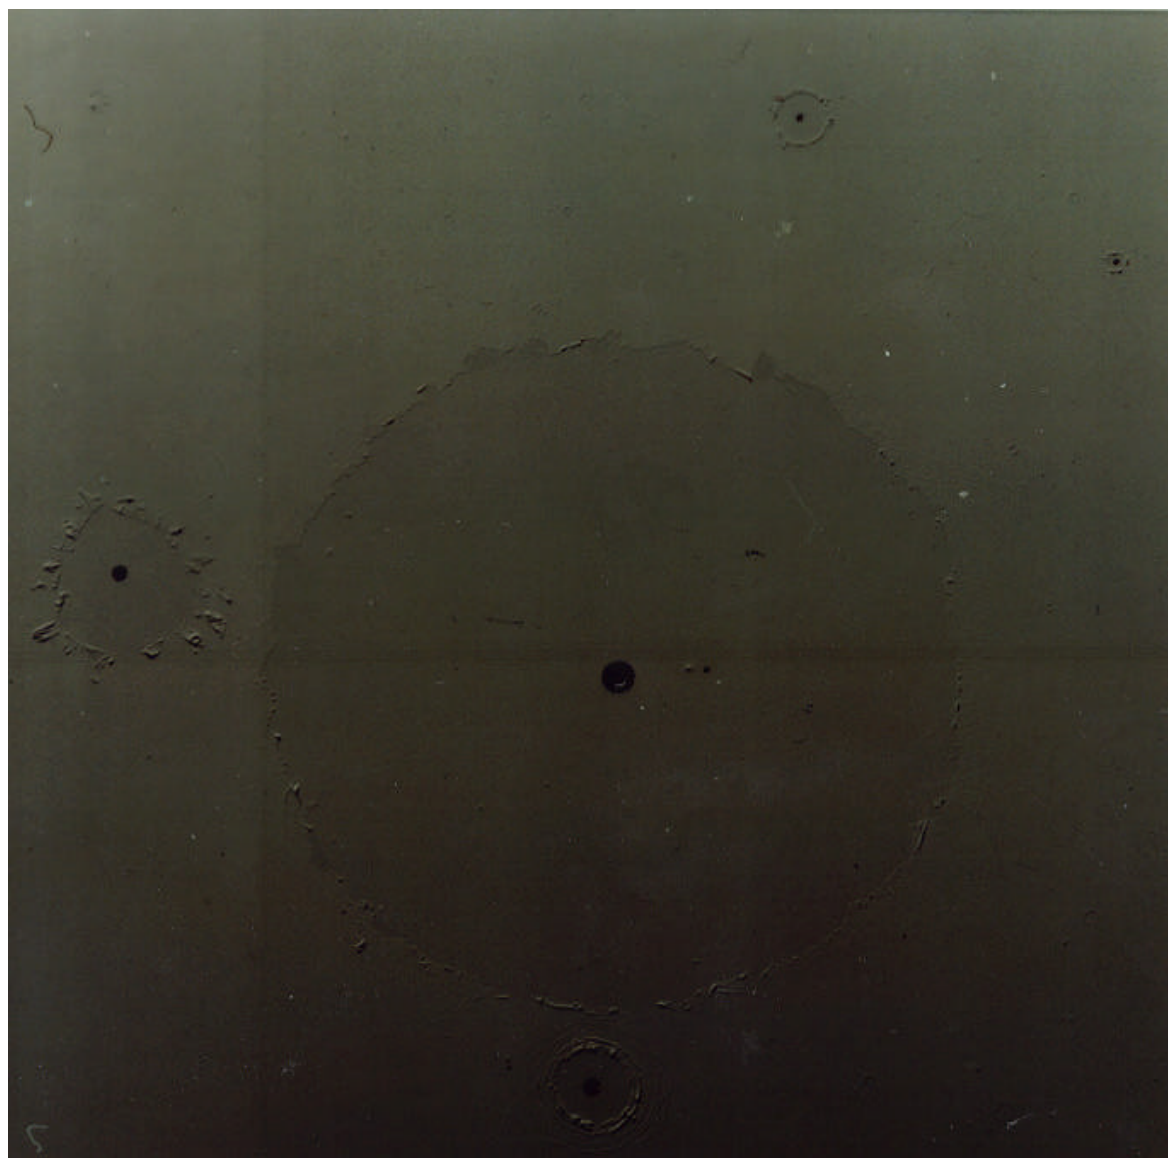
Close-up of impacts on painted aluminum surface from LDEF, NASA photo

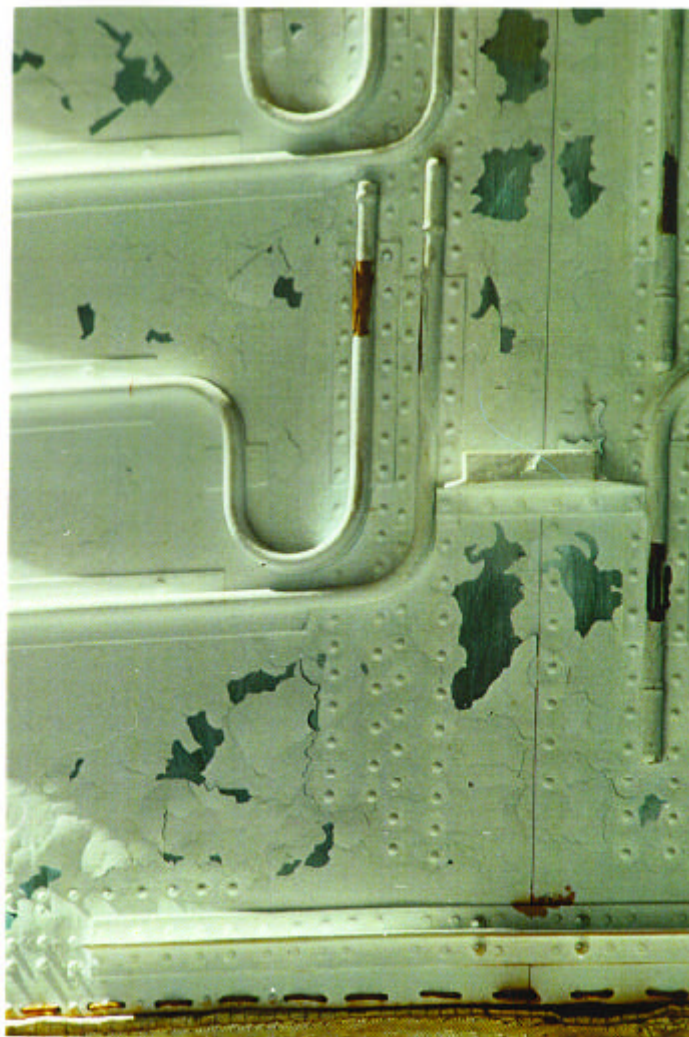
While paint on MIR showing effects of multi-year exposure to space environment

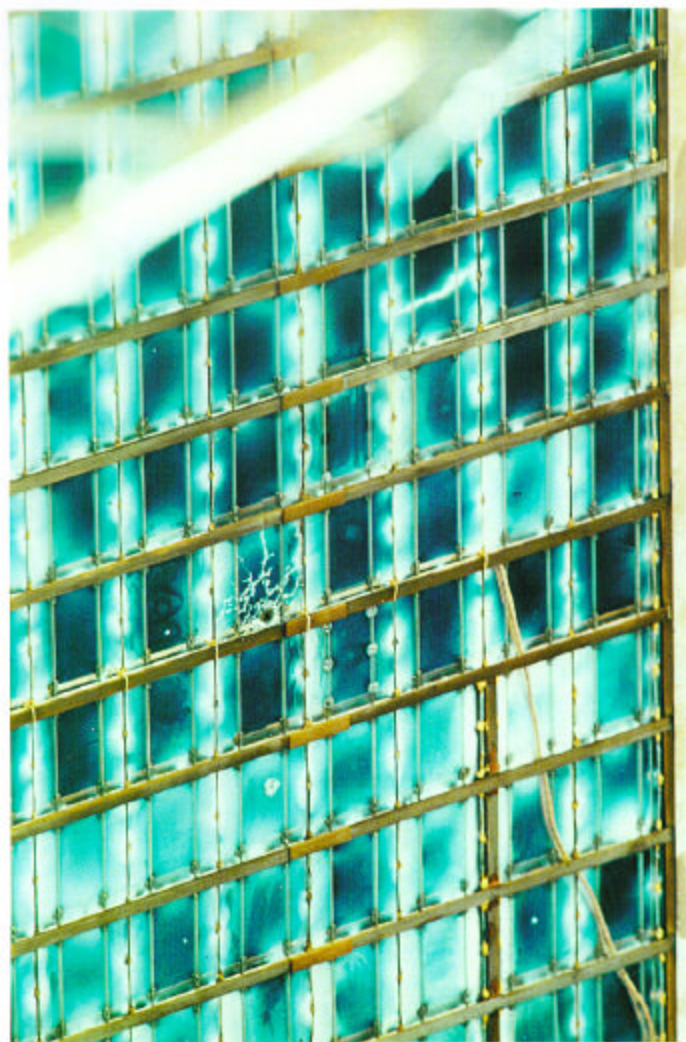
NASA photo of MIR solar array panel showing impact damage at certain locations

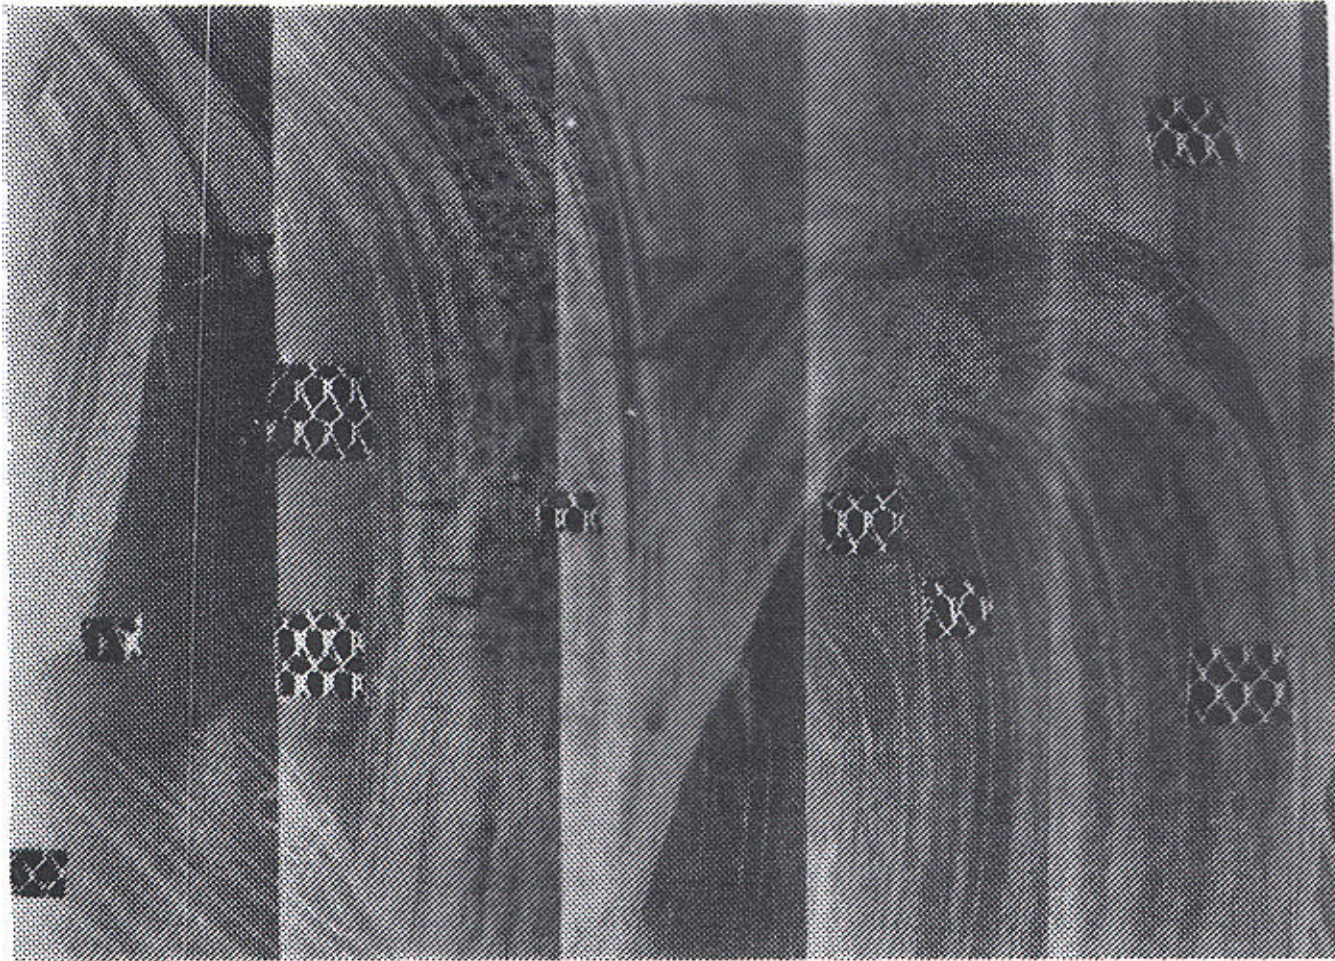
NASA photo showing Kapton blanket retrieved from Solar Max satellite, wipe marks from attempted pre-flight cleaning are clearly visible

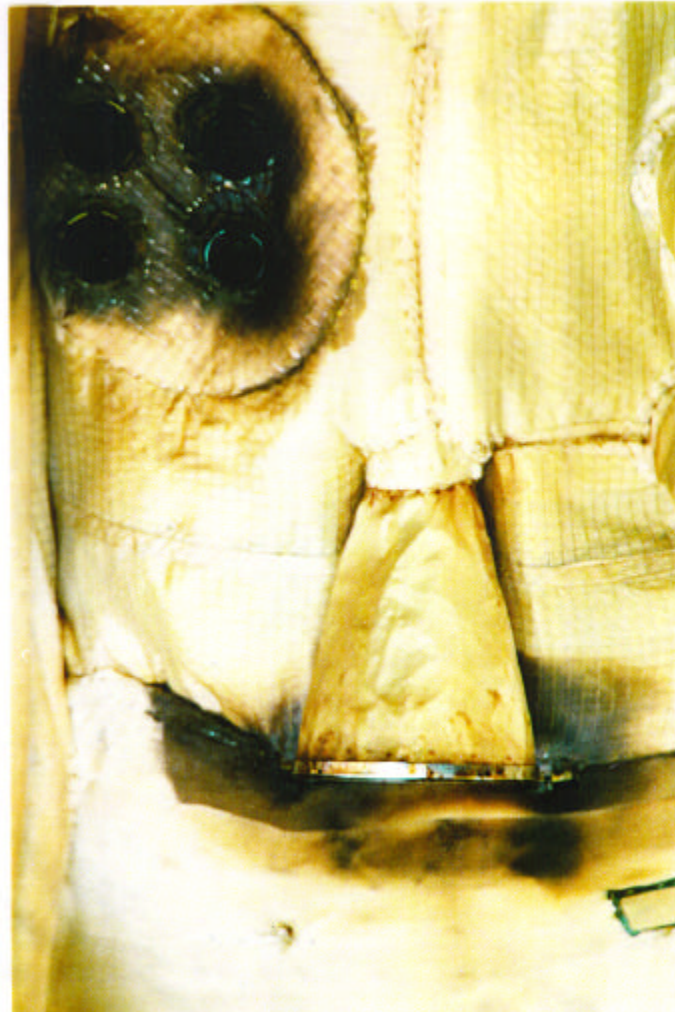
NASA photo showing darkening around thruster cones on MIR

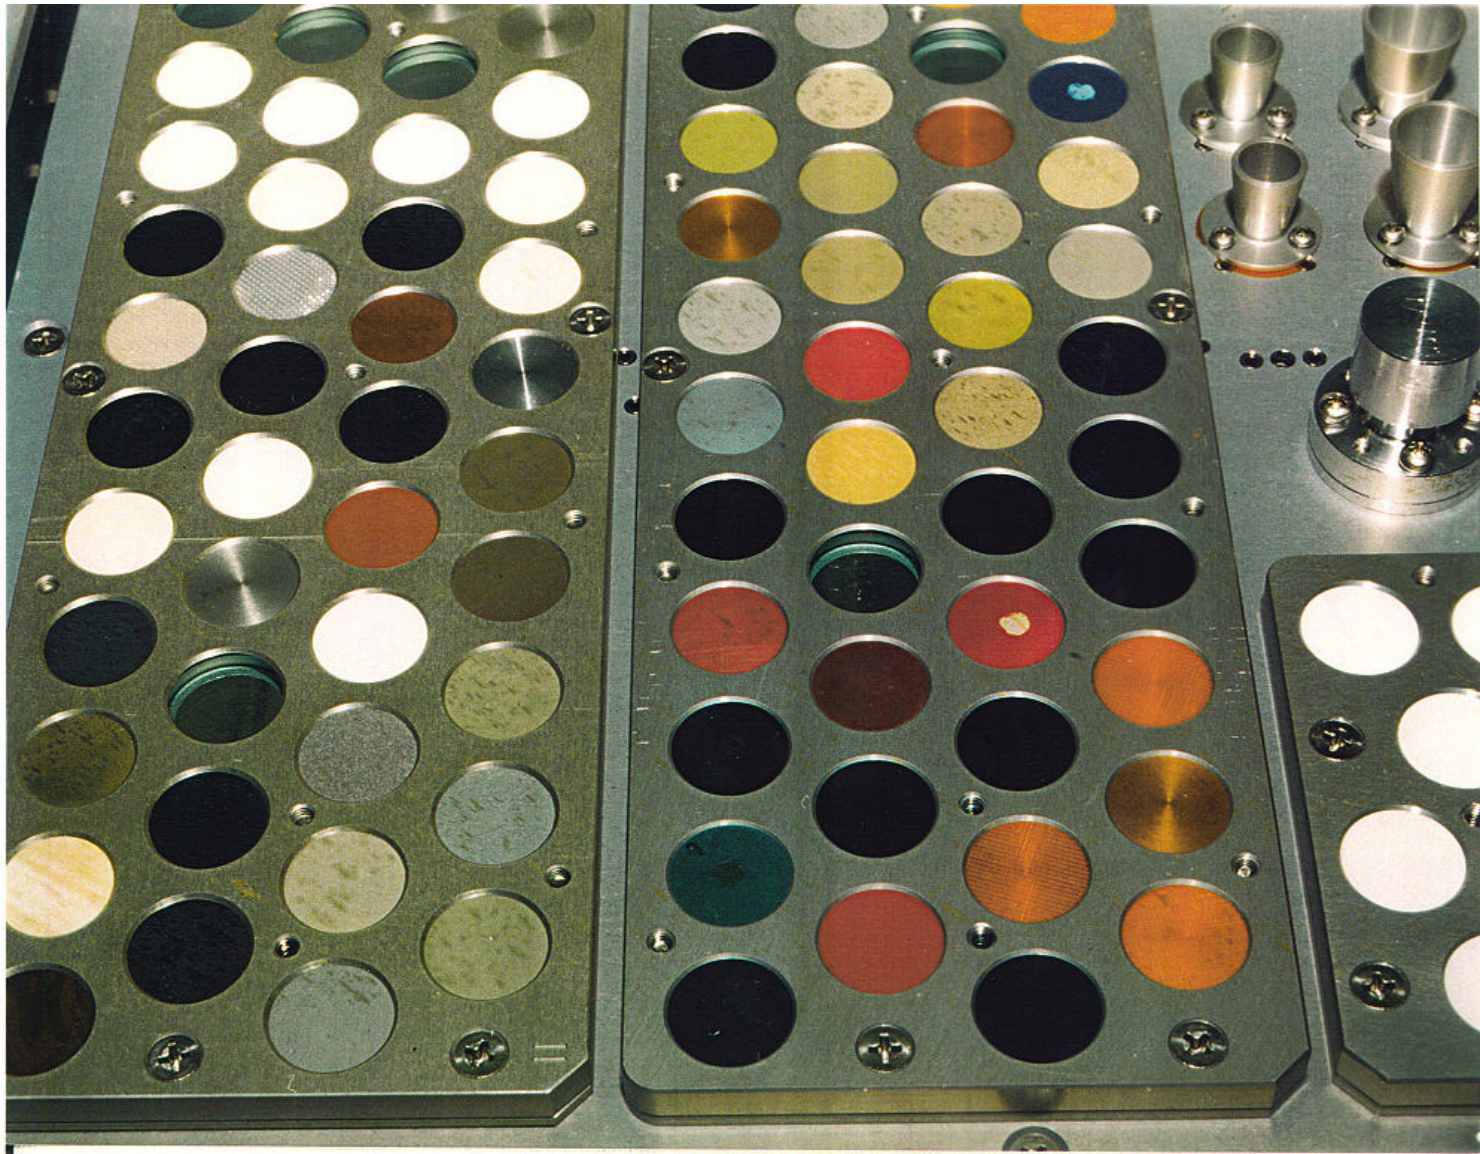
Close-up of part of POSA II experiment hardware showing visible contaminant streaks
